RE: Steelcote Facility - St. Louis, Missouri  
Docket No. VII-91-H-0025

**RESULTS OF CONE PENETROMETER  
TESTS AND REVERSE SLUG TESTS  
STEELCOTE FACILITY  
ST. LOUIS, MISSOURI**

**SHANNON & WILSON, INC.**  
GEOTECHNICAL AND ENVIRONMENTAL CONSULTANTS

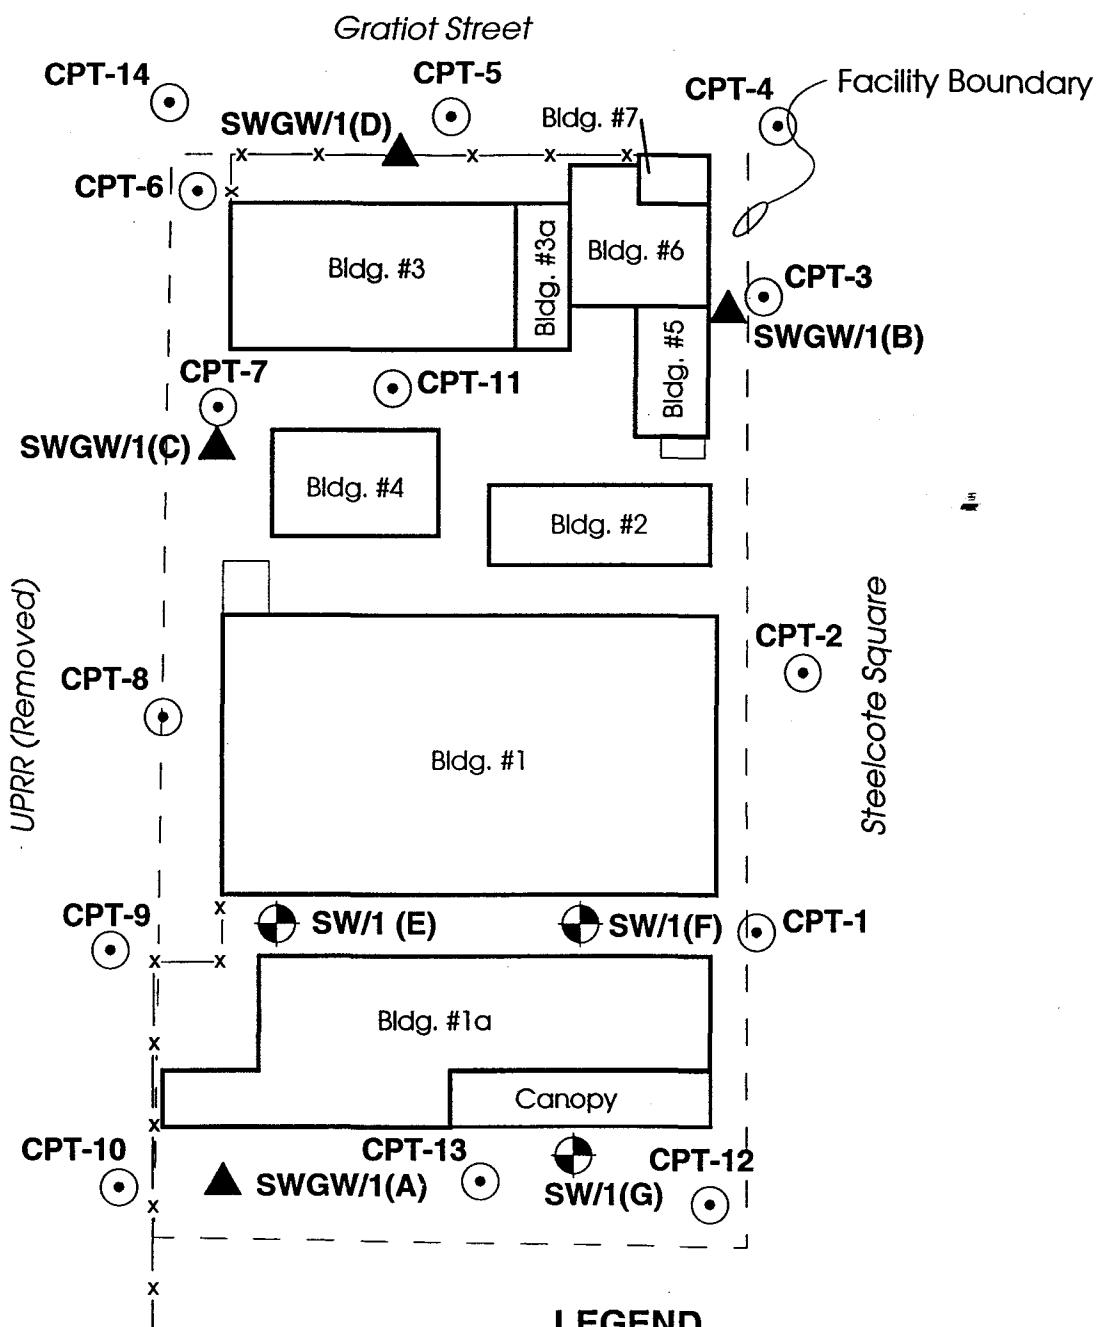
SITE LAYOUT AND TEST LOCATIONS  
STEELCOTE FACILITY  
ST. LOUIS, MISSOURI

Cone penetrometer testing was conducted June 14-16, 1993, at the site at the locations shown in Figure 2. A total of 14 locations were tested. Two of the proposed locations on the north and south perimeter of Building #1 were not tested due to inaccessibility. CPT work was conducted using a truck-mounted rig for pushing the rods and instrumented probe into the subsurface and connected to the portable field computer for data collection. The testing was done in accordance with Technical Procedure #10 presented in Addendum #2 to the POS.

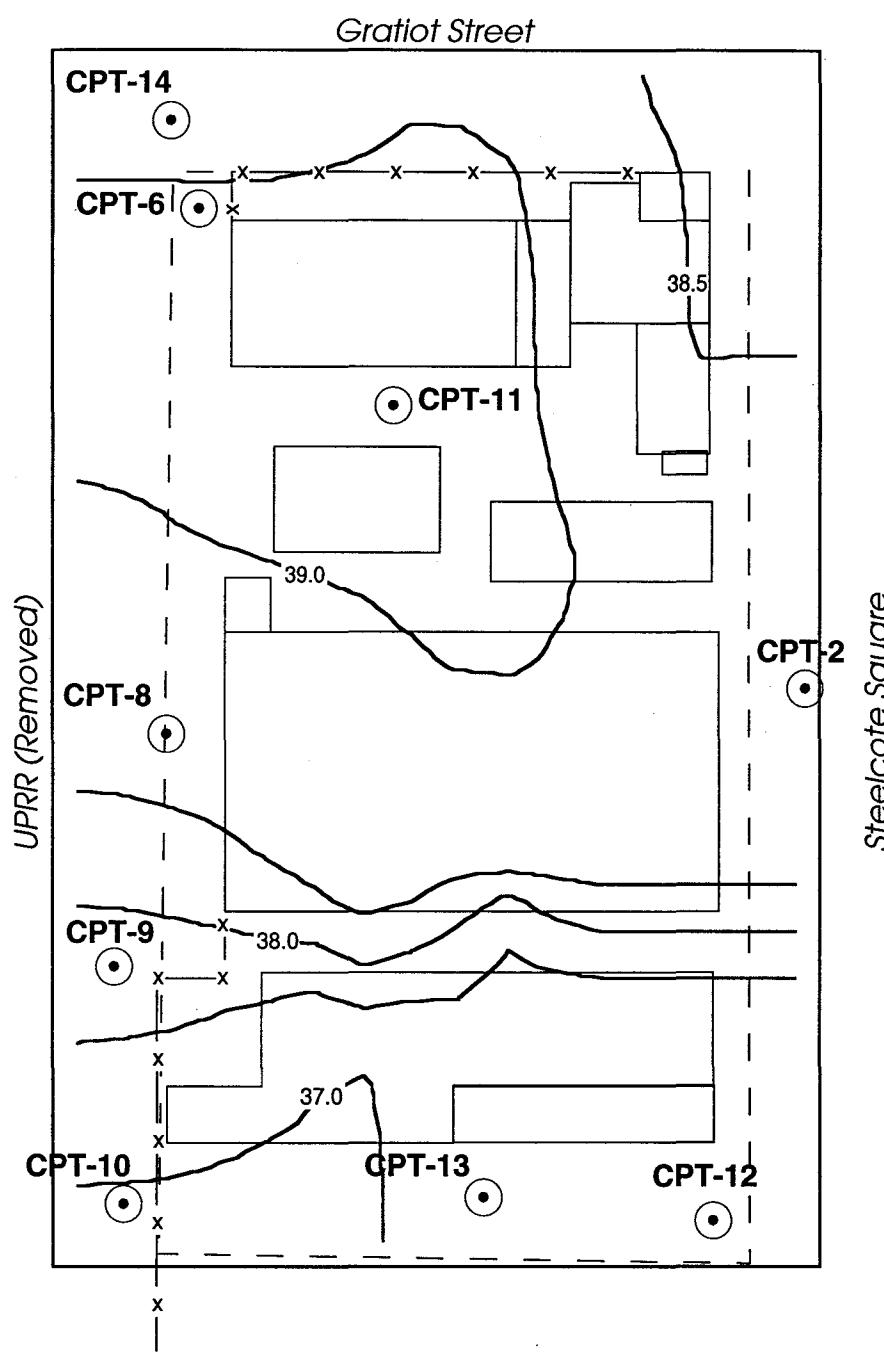
**BEDROCK CONTOURS**  
**STEELCOTE FACILITY**  
**ST. LOUIS, MISSOURI**

The apparent depth to bedrock, based upon resistance to further penetration by the probe, varied from approximately 57 to 60 feet below the ground surface. A contour map of the apparent depth to bedrock at the site is presented in Figure 4. The consistent depth to bedrock indicates no karst features at the top of bedrock. In addition, no man-made structures were encountered at depth during the CPT investigation. Generalized geologic cross sections are shown in Figures 5 and 6. Note that the boundaries depicted for the different soil types are gradational and that the soil type shown represents the soil type which predominates in that interval. The soil behavior types identified with the CPT work is consistent with the information generated during the Spring 1992 drilling and sampling program. The CPT work indicates the presence of isolated and possibly perched water, as discussed further below in this section.

Approx. CPT location used  
for top of bedrock  
determination

The CPT investigation indicates that the subsurface geology across the site is consistent with the geology observed during the drilling, sampling, and monitoring well installation work conducted in Spring, 1992. Depth to bedrock was within the range previously encountered and the general stratigraphy was similar. No evidence of karst features or man-made structures was indicated by the CPT investigation. The presence of a confining layer or discreet and isolated water-bearing zones accountable for the observed ground water conditions were not identified in the interpreted soil data, however, the pore pressure data suggests that separate water-bearing zones may be present.

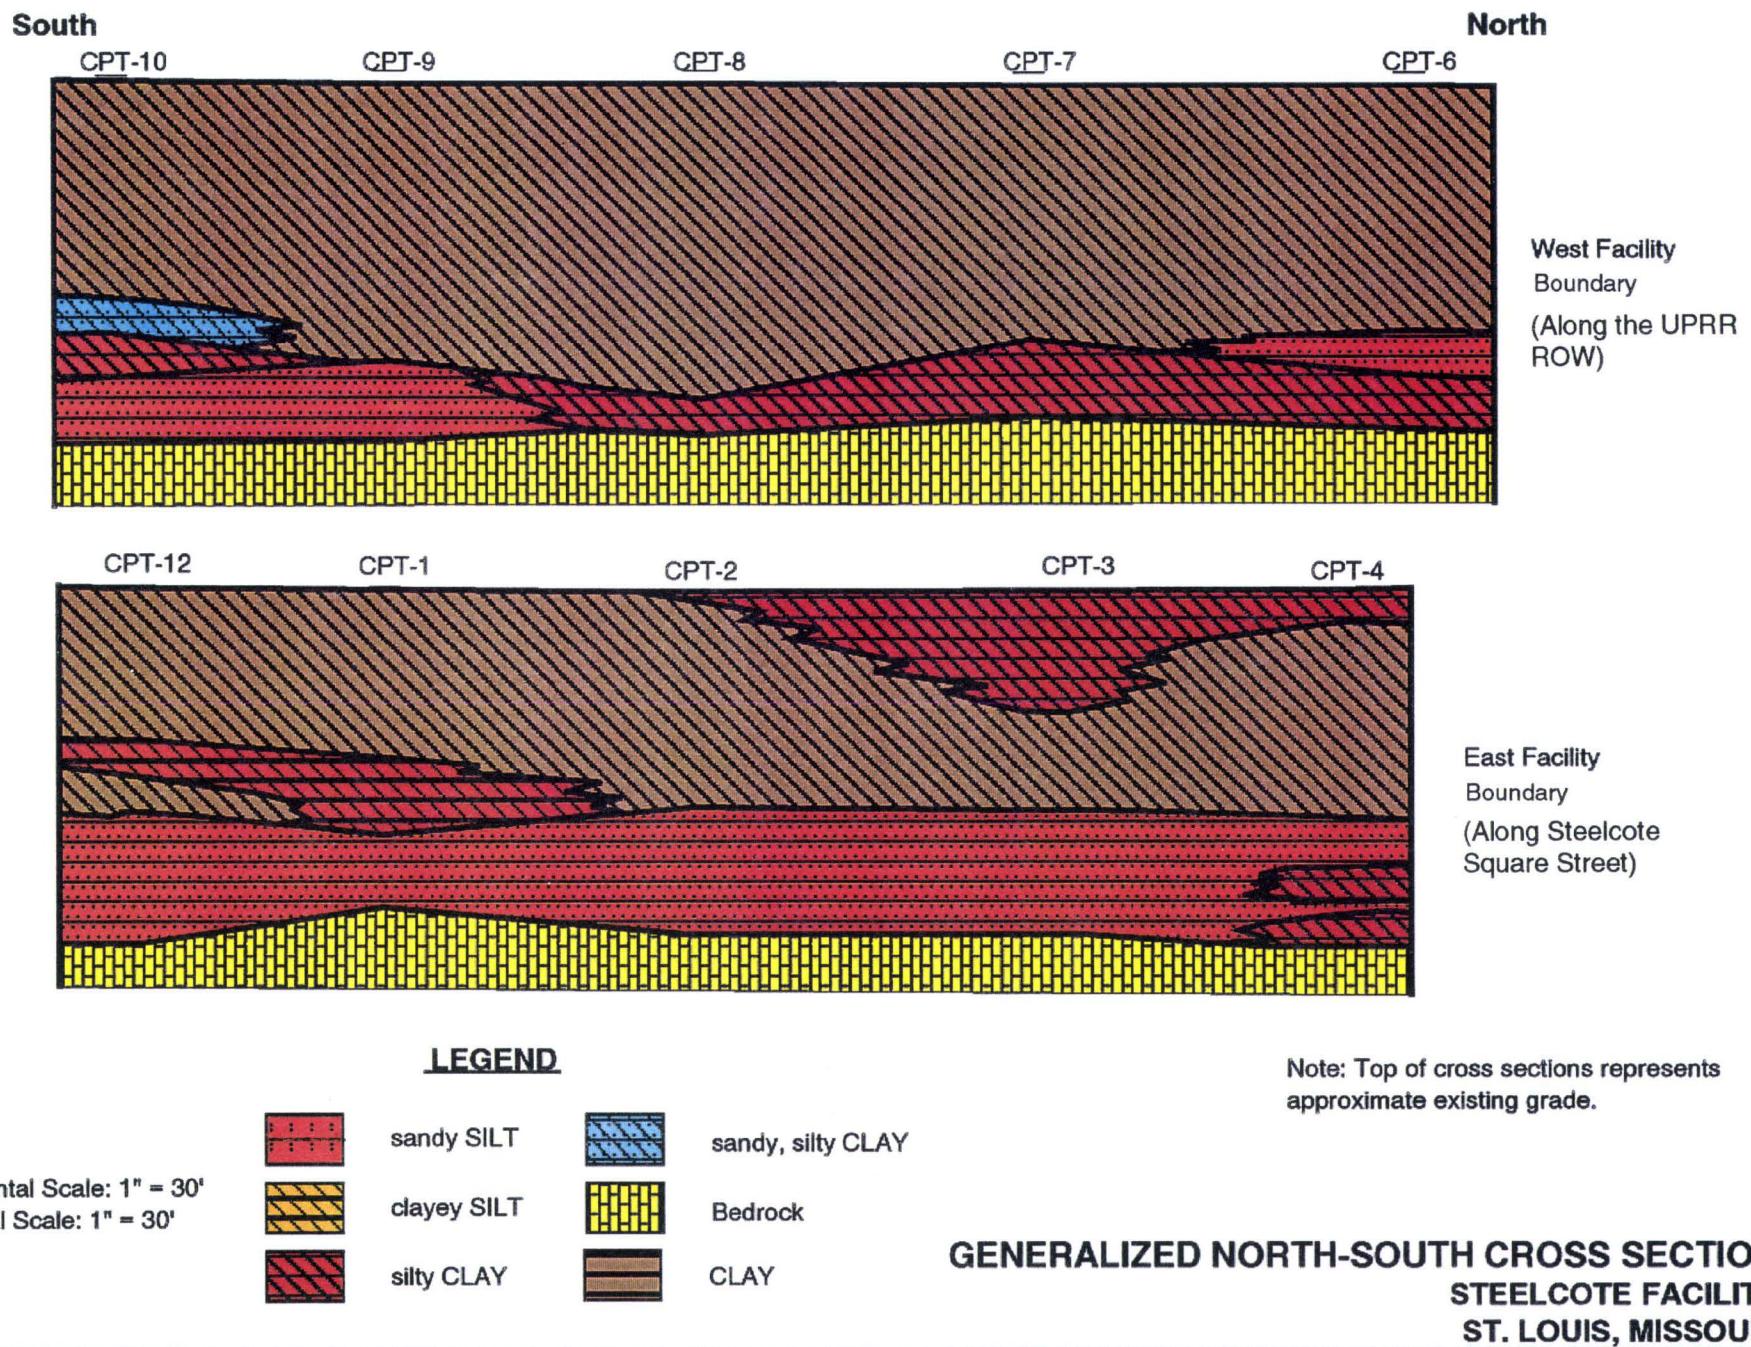
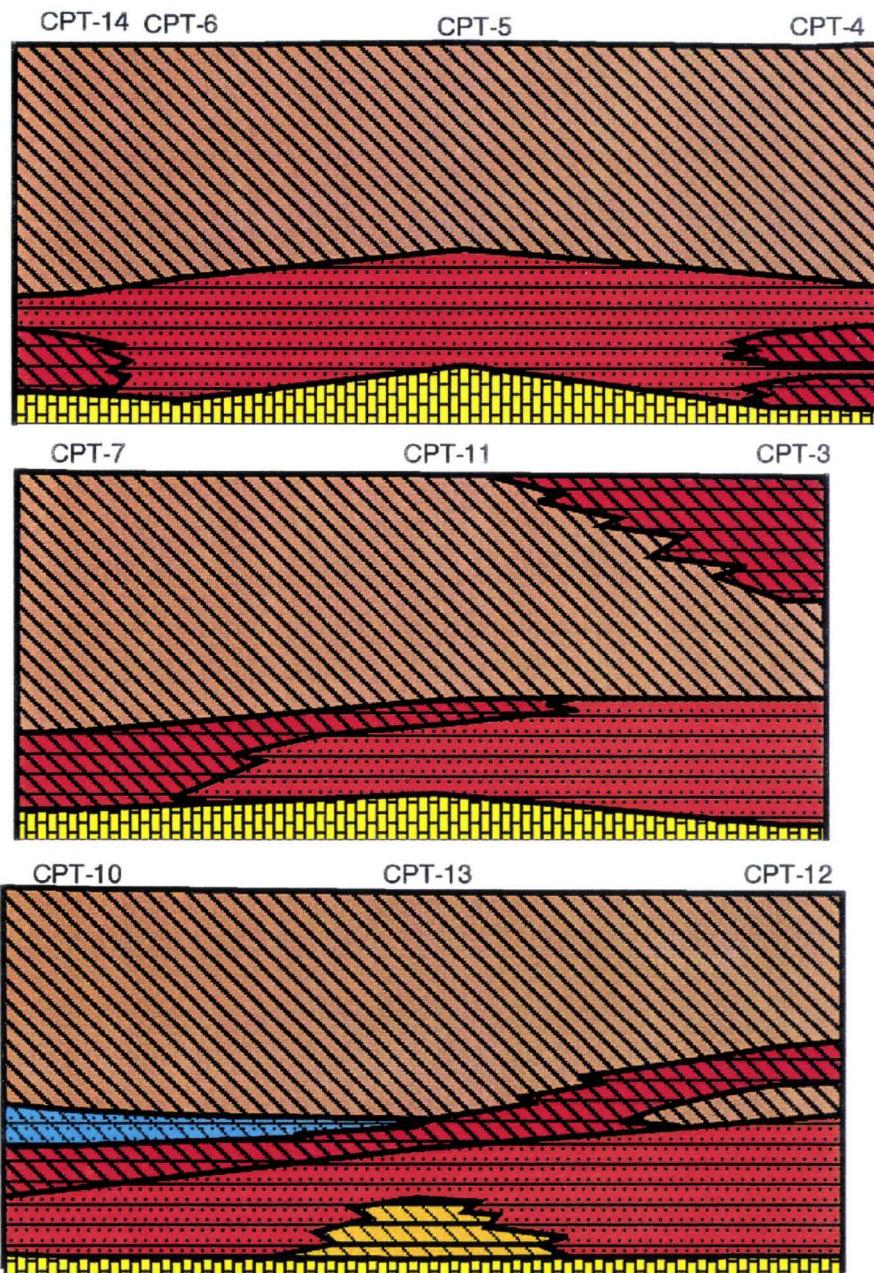
**GENERALIZED EAST-WEST CROSS SECTION**  
**STEELCOTE FACILITY**  
**ST. LOUIS, MISSOURI**

In general, the CPT data indicate silty clay and clay to be present to depths of 30-35 feet. Below 35 feet there is variation, however the overall trend is for the soil to be more silty and locally trace to slightly sandy. At about 40 feet and extending to about 45 feet, the soil is predominantly sandy silt and silty sand in the northern portions of the site. The southern portion of the site at this depth interval appears to be more clayey silt to silty clay with trace sand. Note that this interval appears to be the primary water-transmitting strata at the site. Below 45 feet, the data indicates variation from sandy silt to silty clay and clayey silt.

sandy SILT
	clayey SILT
	silty CLAY
	sandy, silty CLAY
	Bedrock
	CLAY

Note: Top of cross sections represents  
approximate existing grade.

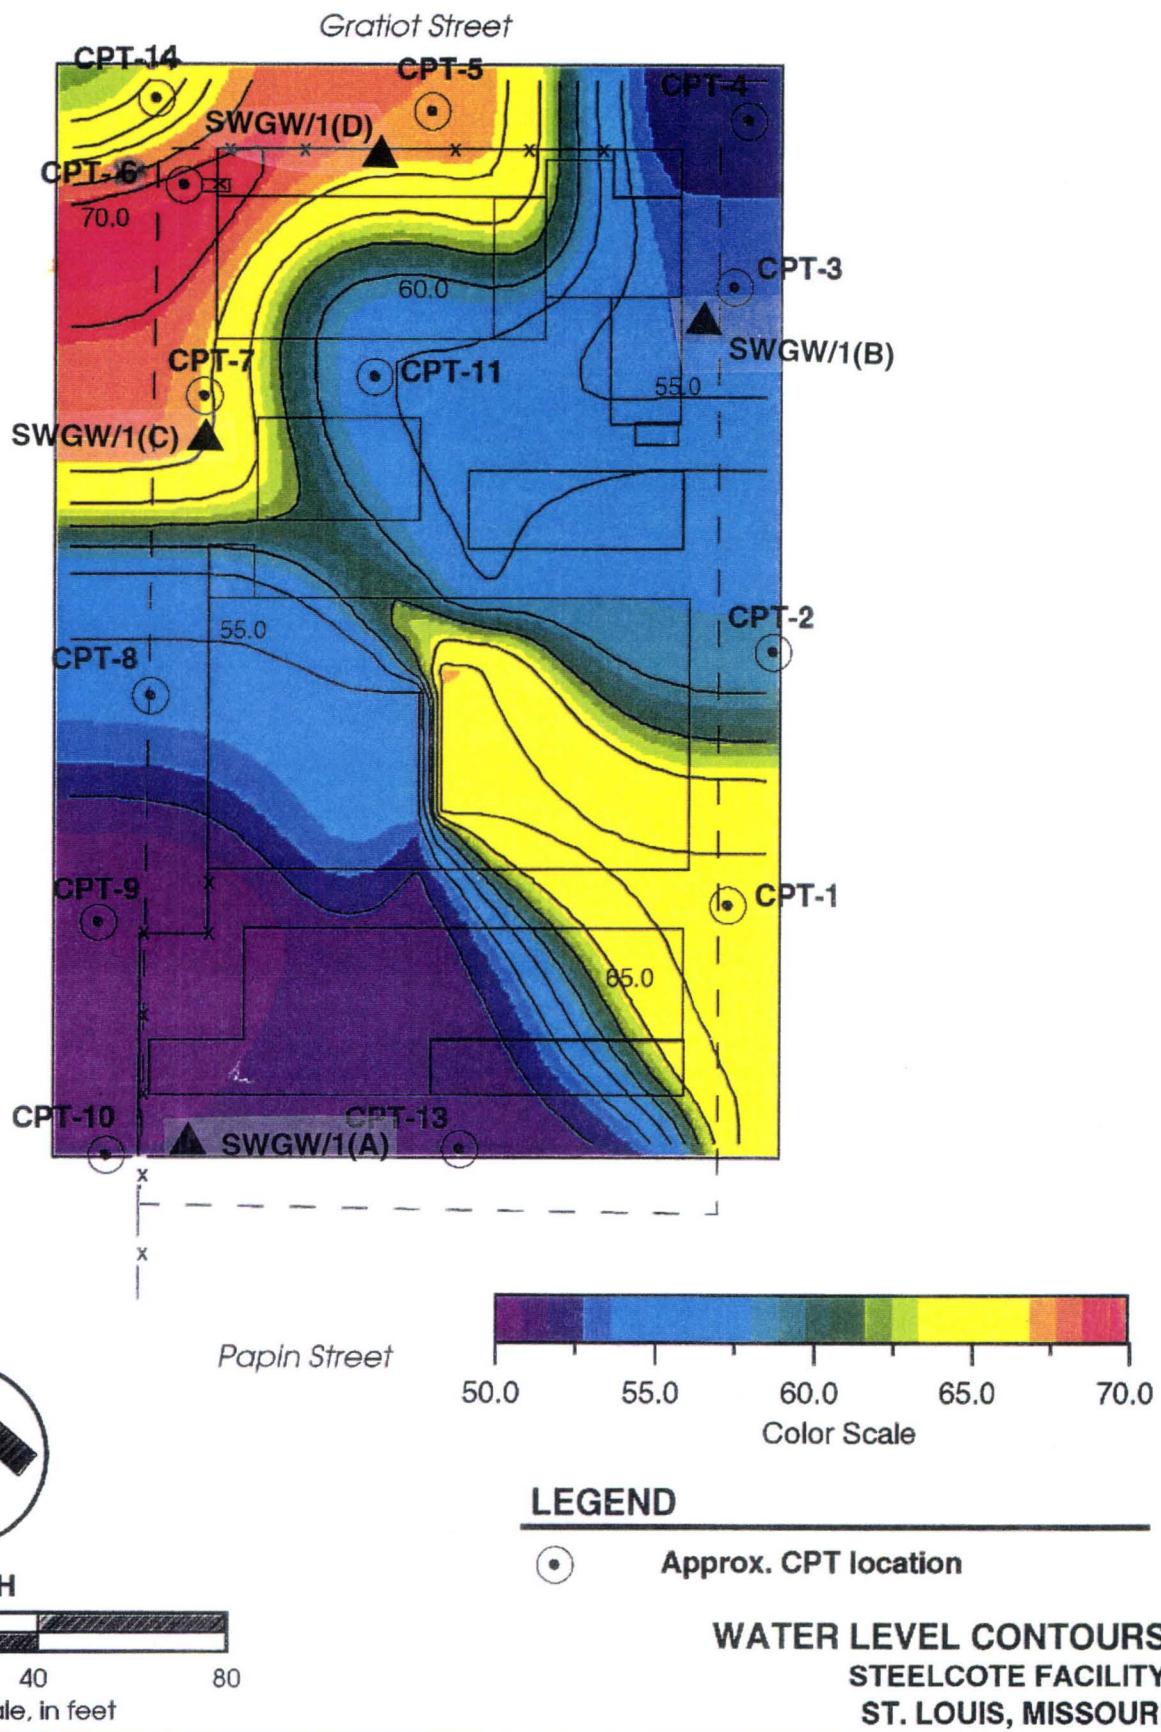
Water levels expressed as depth below ground surface varied between approximately 24 to 47 feet. A ground water contour map is presented in Figure 7. The data indicated water levels which were consistent with those measured previously and currently in the existing monitoring wells and a contoured plot of the ground water elevations did indicate a consistent picture of the apparent ground water flow pattern at the site (Figure 7).

The plot indicates ground water highs at the northwest and southeast ends of the site and ground water lows at the northeast and southwest areas of the site. It appears there are ground water "valleys" trending approximately northeast and southwest. The apparent direction of ground water flow is complex with indications that a ground water divide is present trending northwest-southeast. It suggests that water in the northeast portion of the site flows southerly or easterly and eventually toward the northeast off the site and that ground water in the southeast portion of the site flows north. Ground water in the northwest portion of the site appears to flow south and east and ultimately flows to the west off the site. In the far northwest corner, flow appears to include a northerly component. Ground water in the southwest portion of the site appears to flow north to northwest and ultimately flows to the the west off the site. These conditions may also be, in part, the result of surface and subsurface structures. Nevertheless, the general pattern of ground water flow appears to be consistent with the apparent ground water flow direction determined by the monitoring wells.

The pore pressure data from CPT locations 6 and 14, which are within 20 feet of each other, indicated water levels of approximately 24 feet and 36 feet from the ground surface. Note also that the water levels determined in CPT locations 11 and 14 are also consistent with each other. This difference in water level in such a short distance suggests that at least two different water bearing zones are present, with the different level possibly representing either an isolated or perched ground water condition.

The CPT pore pressure data indicates ground water highs at the northwest and southeast ends of the site and ground water lows at the northeast and southwest areas of the site. It appears there are ground water "valleys" trending approximately northeast and southwest. The apparent direction of ground water flow is complex with indications that a ground water divide is present trending northwest-southeast. Although the ground water elevations are different from the four wells, the general pattern is similar to the apparent ground water flow direction based upon the wells. The pore pressure data indicates a complex ground water flow pattern and that water apparently leaves the site toward the west, northeast, and possibly northwest.

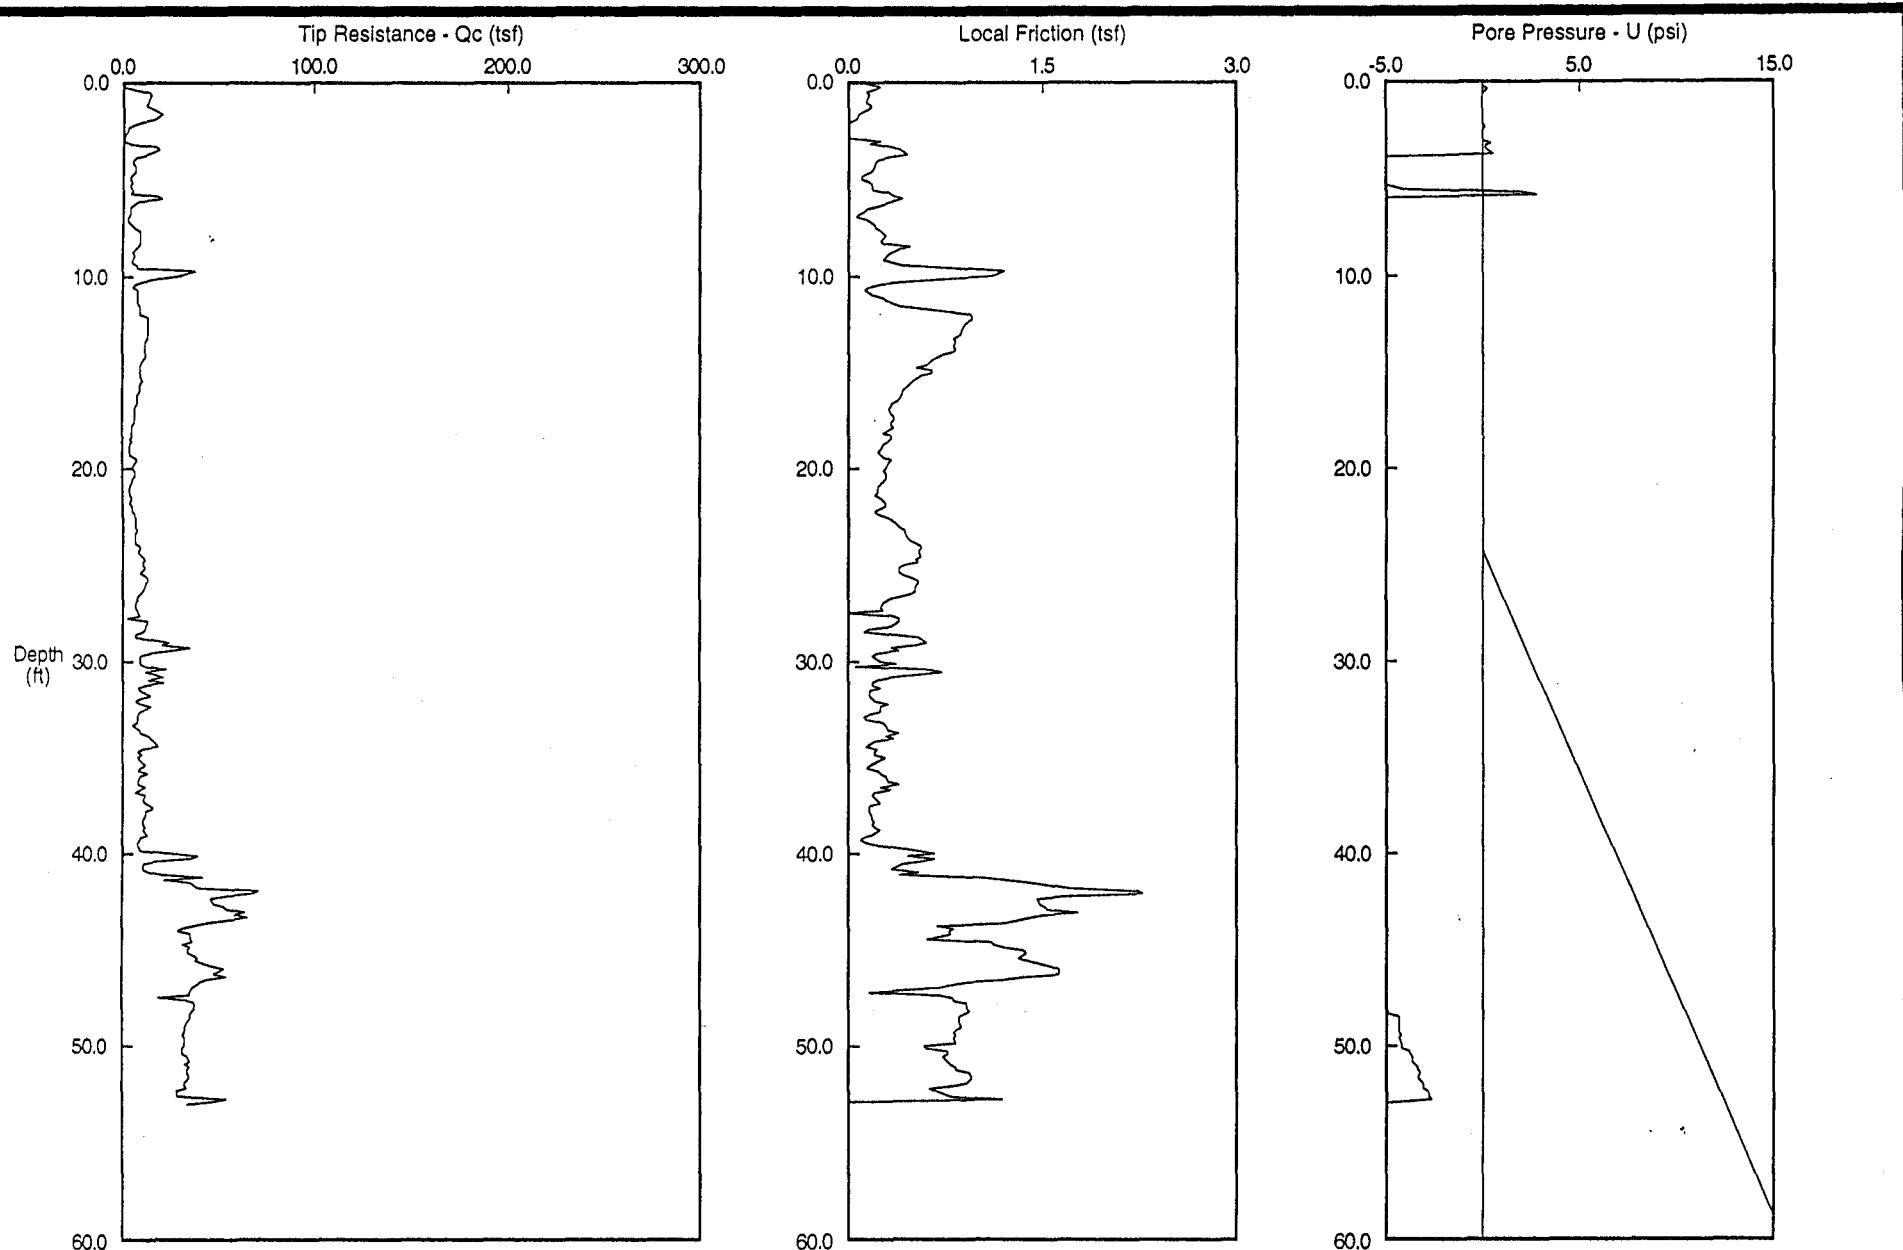
PLOT OF CPT-1  
Steelcote

The data generated during the cone penetrometer testing were processed with a computer program written at the University of British Columbia, Vancouver, British Columbia. It is an interactive program which is compatible with the data format of the Hogentogler & Company field computer systems. The program reduces and formats the raw data which aids in the interpretation of the soil behavior, equivalent relative density, angle of internal friction, equivalent SPT N value, corrected SPT N1 value, cyclic stress ratio, and undrained shear strength. These data are presented in Appendix B as Tables B1-B14 and Figures B1-B14. Such data aid in the interpretation of site hydrology and geology and includes the graphical presentation of the tip resistance, local friction, and pore pressure, and the interpreted CPT

profile. It also permits determination of apparent bedrock and development of a ground water contour map generated using the pore pressure dissipation data.

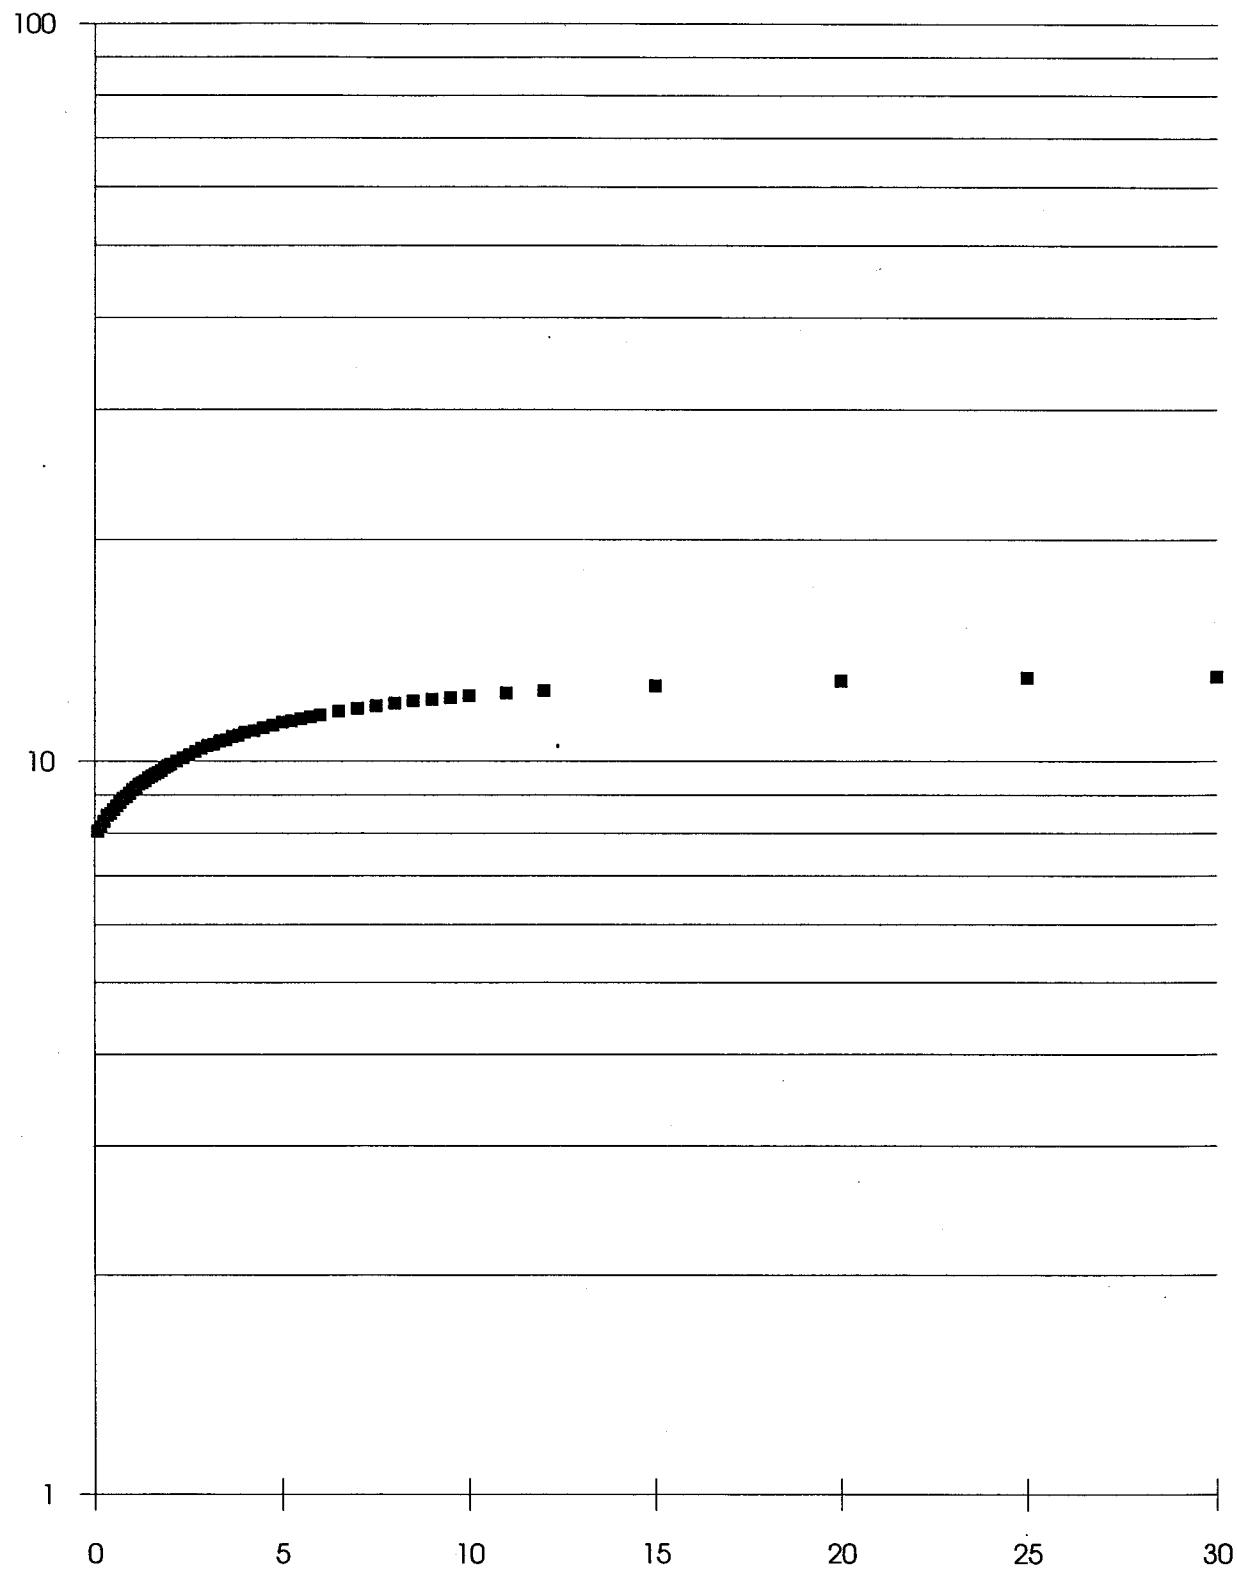
FIGURE C-1

Reverse Slug Test  
Well SWGW/1(A)

Depth (ft) vs. Time (min)

The ratio of the change in head to the head at the start of the test ( $h/h_0$ ) was calculated and then plotted versus time on semilogarithmic paper and are shown in Appendix C Figures C4-C8. The time-drawdown data tended to plot in a straight line, as expected, with some deviation observed in Well A. The data suggests that the combined response of the filter pack and formation at the outset of the test shifted to reflect more the influence of the formation.

The hydraulic conductivity values calculated for the wells ranged from  $3.20 \times 10^{-6}$  to  $2.11 \times 10^{-5}$  cm/sec. These values are comparable to the calculated values from the slug tests conducted in May and June, 1992 when the hydraulic conductivities ranged from  $4.87 \times 10^{-5}$  to  $1.89 \times 10^{-5}$  cm/sec.

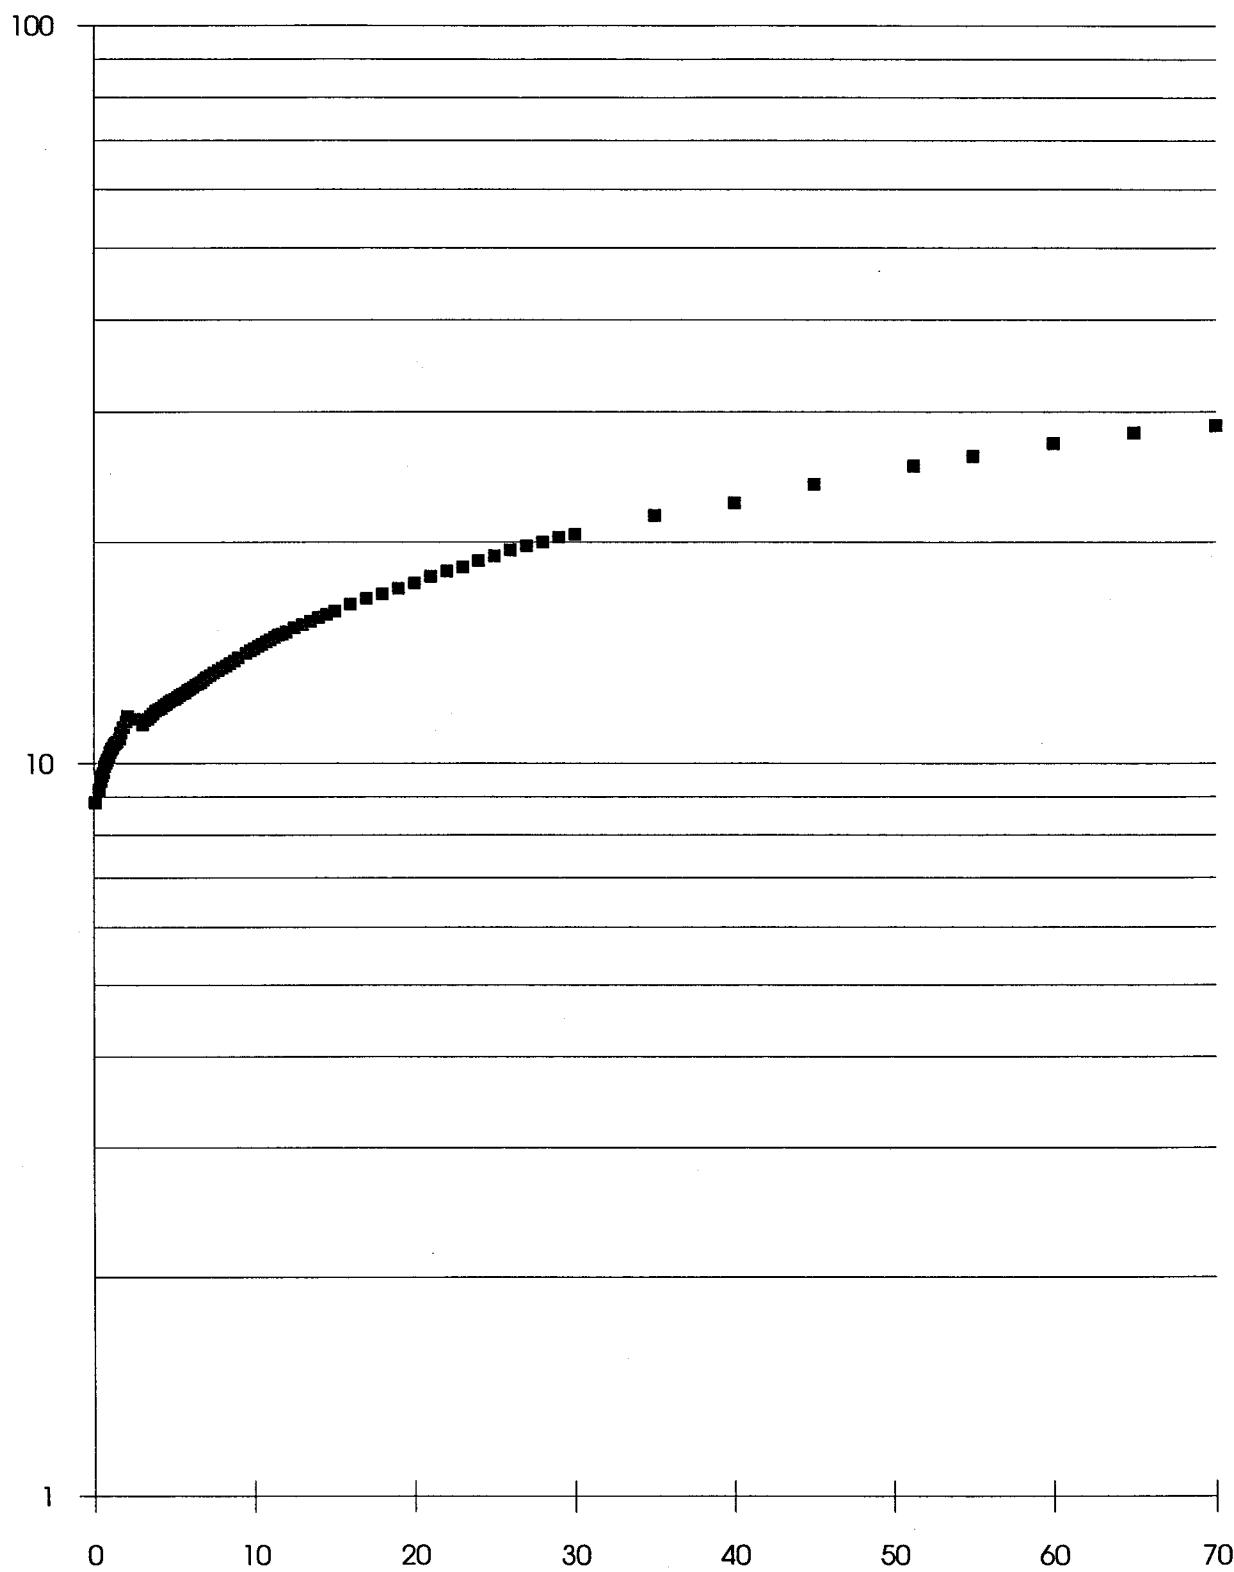
FIGURE C-2

Reverse Slug Test  
Well SWGW/1(B)

Depth (ft) vs. Time (min)

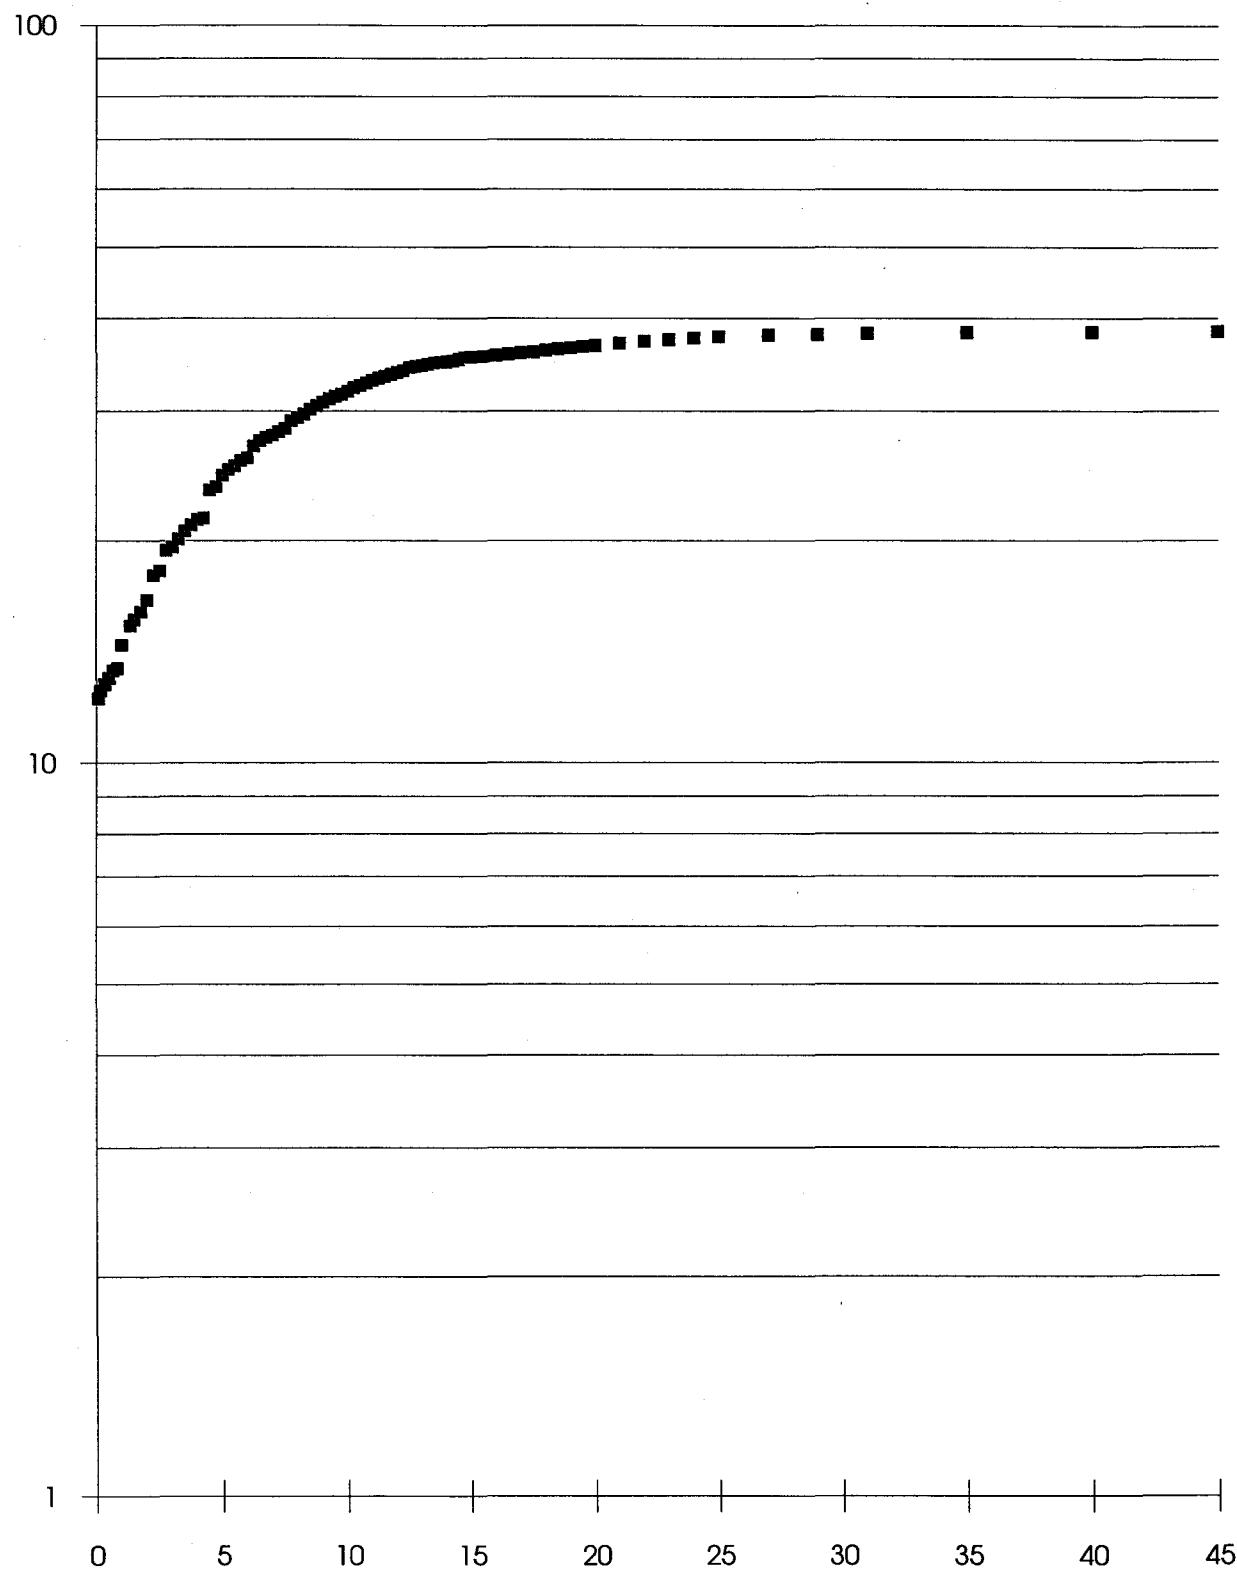
FIGURE C-3

Reverse Slug Test  
Well SWGW/1(C)

Depth (ft) vs. Time (min)

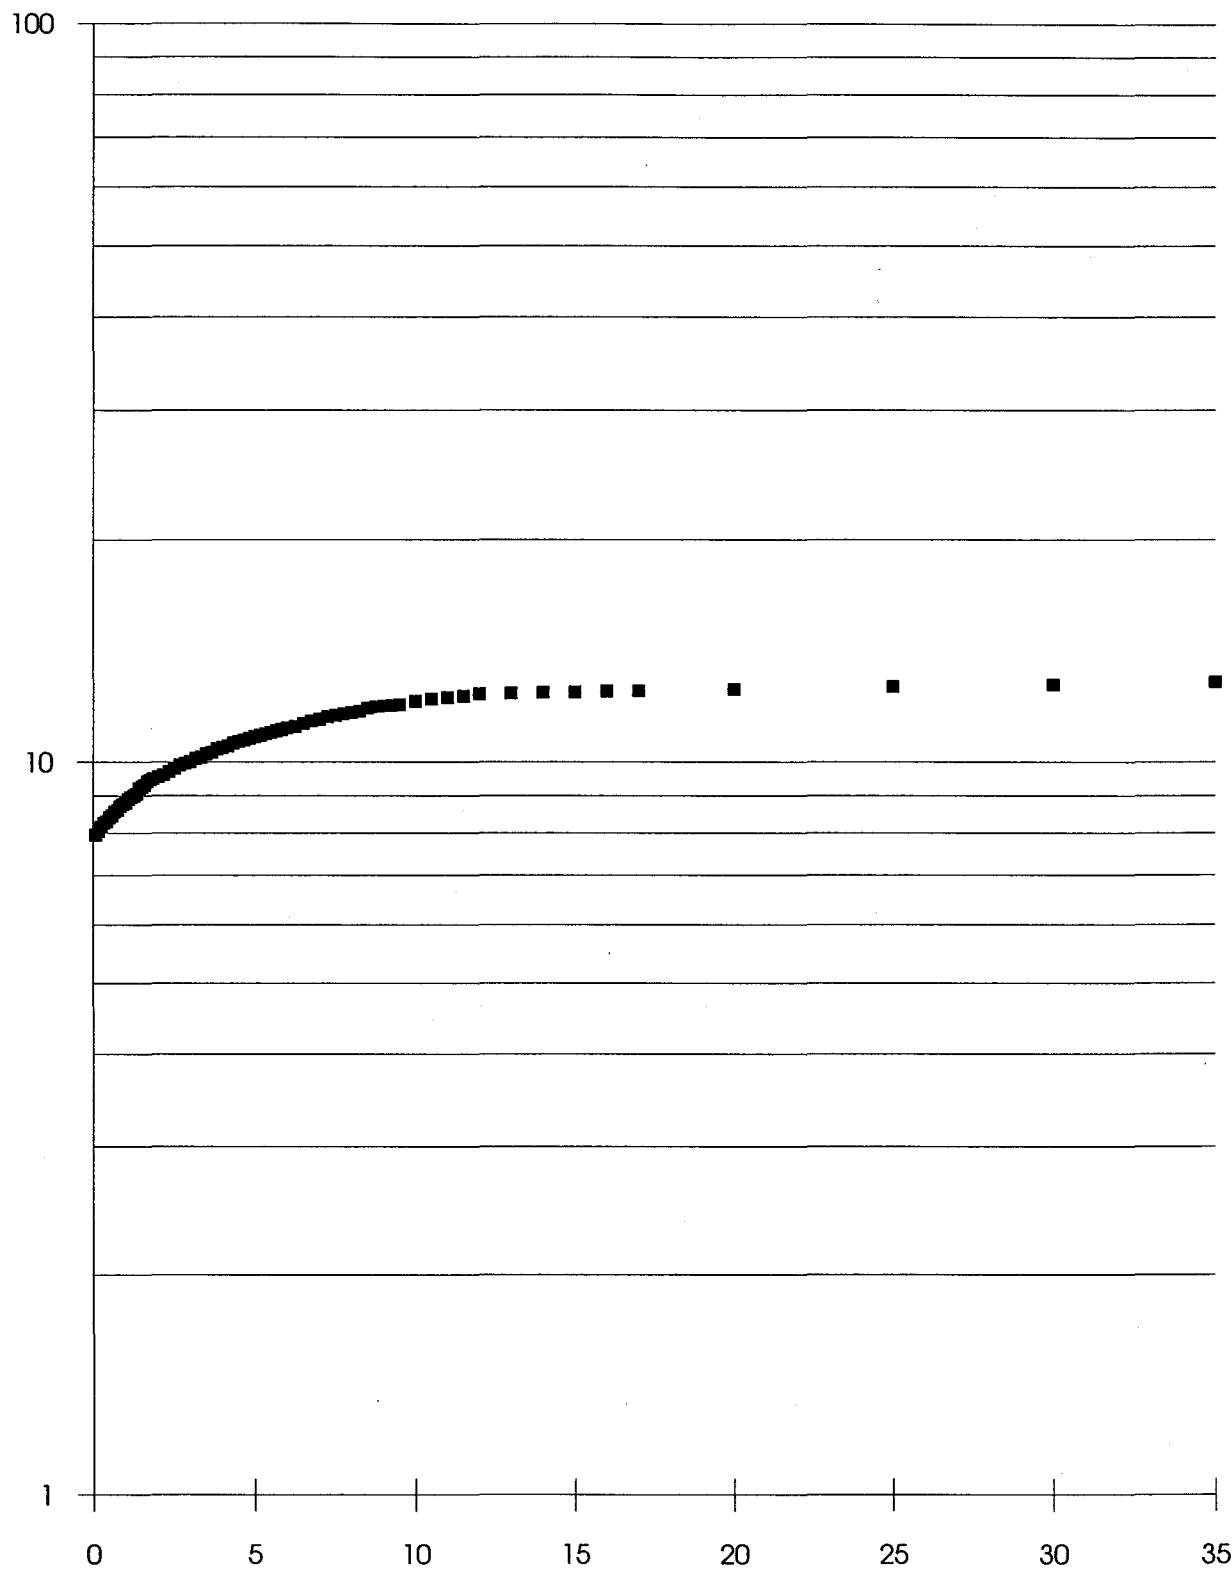
FIGURE C-4

Reverse Slug Test  
Well SWGW/1(D)

Depth (ft) vs. Time (min)

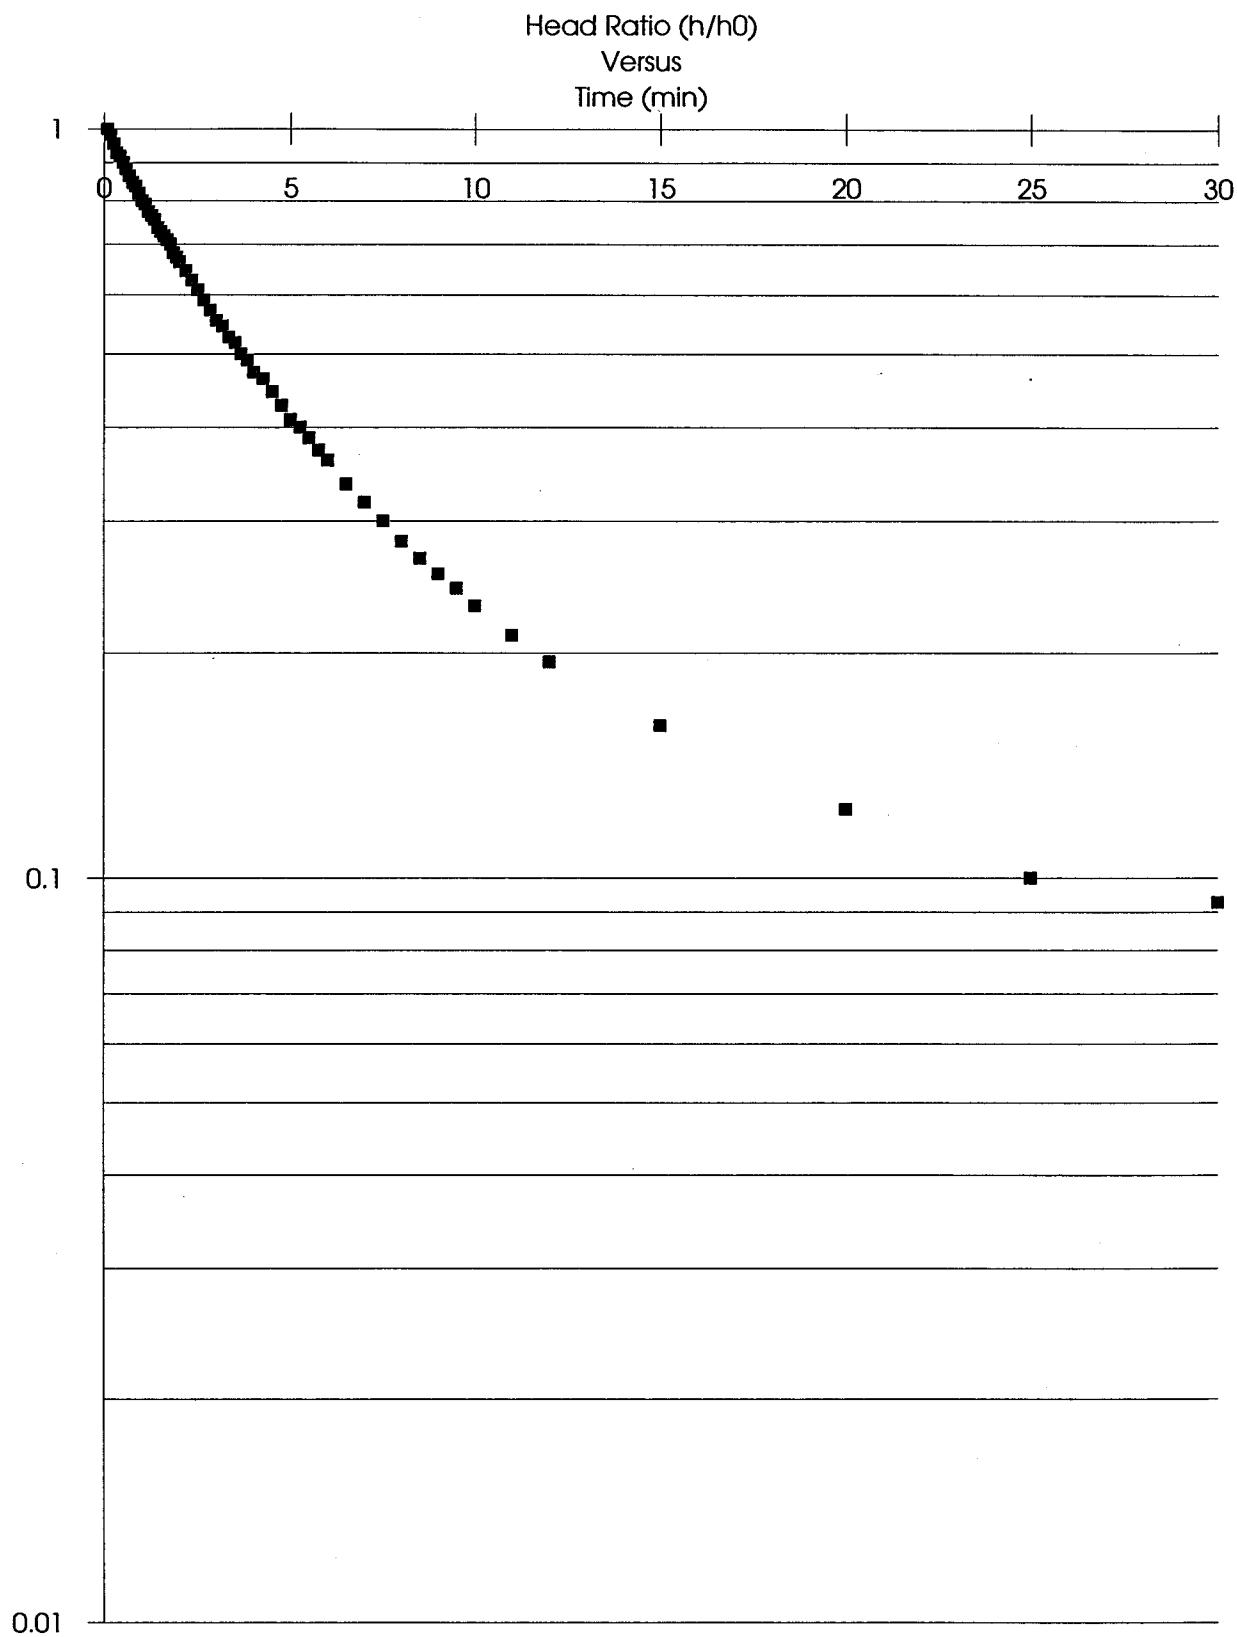
FIGURE C-5

Reverse Slug Test  
Well SWGW/1(A)
